FINAL REPORT - Draft

McDougle Middle School Bioretention Area and Cistern Installation

Biological and Agricultural Engineering Department
North Carolina State University
Raleigh, North Carolina

Town of Carrboro
Carrboro, North Carolina

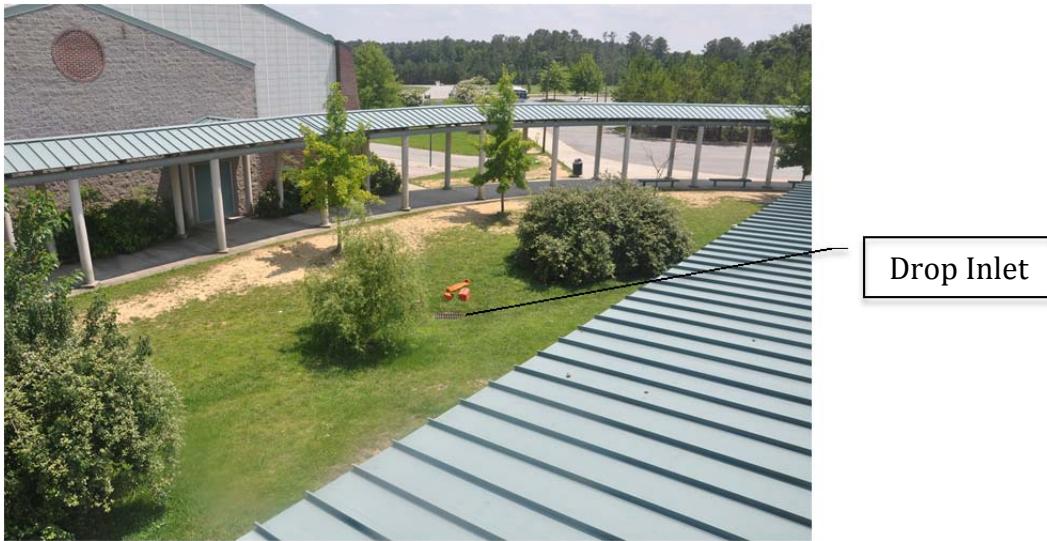
The McDougle bioretention area was installed in a grassed courtyard adjacent to the school gymnasium. This highly visible area made for an effective demonstration and education site. A permanent educational sign was installed adjacent to the garden to educate students, teachers, and parents about the impacts of stormwater pollution and how bioretention areas can improve water quality (Appendix A). Prior to this project, runoff from adjacent roofs, sidewalks, and a brick courtyard discharged directly to a drop inlet, which eventually discharged to a tributary to Bolin Creek (Photograph 1).

Photograph 1: Stormwater drop inlet prior to bioretention area construction

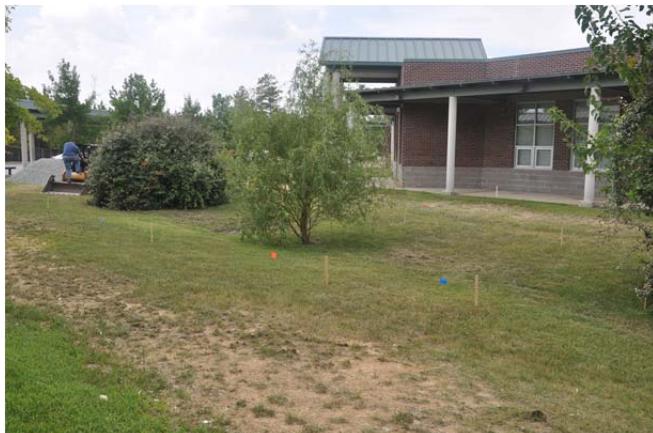
Photograph 2. Before construction.

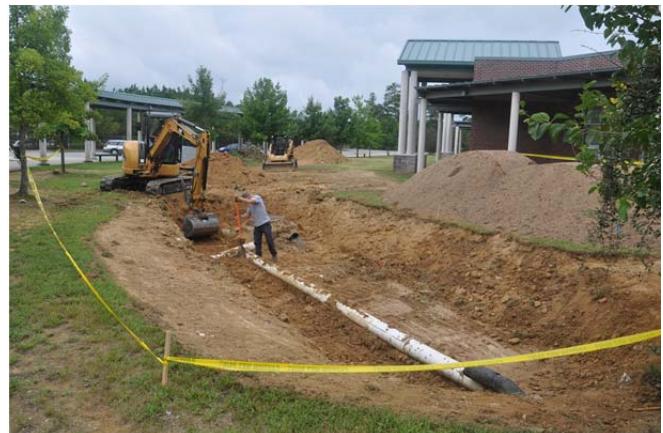
The onsite clay soil was not suitable to infiltrate runoff for the bioretention area. Therefore, the clay soil was excavated and hauled off site to make room for an engineered sandy bioretention media (photographs 2 &3).

Photograph 3: Bioretention area excavation.

The white pipe in photograph 3 was an existing storm pipe that discharges to the drop inlet. This pipe was carefully avoided during the excavation.

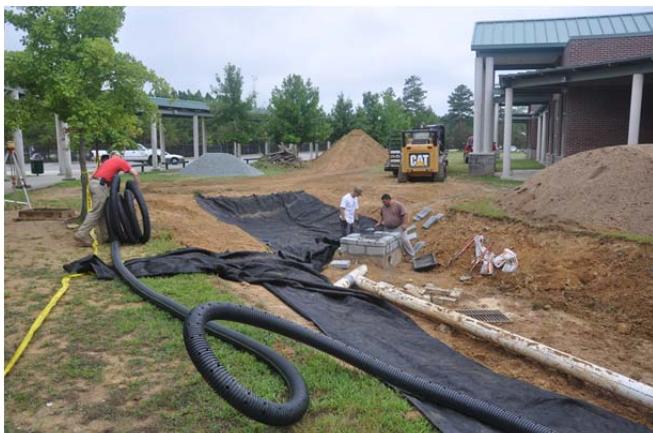
The excavation was lined with a permeable geotextile fabric to allow water to infiltrate while keeping fine soil particles out of the gravel underdrain and sandy media layers (photograph 4). Two four-inch perforated plastic pipes were installed for the underdrains. The underdrains were embedded in a six-inch layer of washed gravel (photograph 5). Two cleanouts were installed in case the underdrains ever get clogged. The underdrains were connected to the drop inlet structure in the middle of the bioretention area.

Photograph 4: Liner installation.

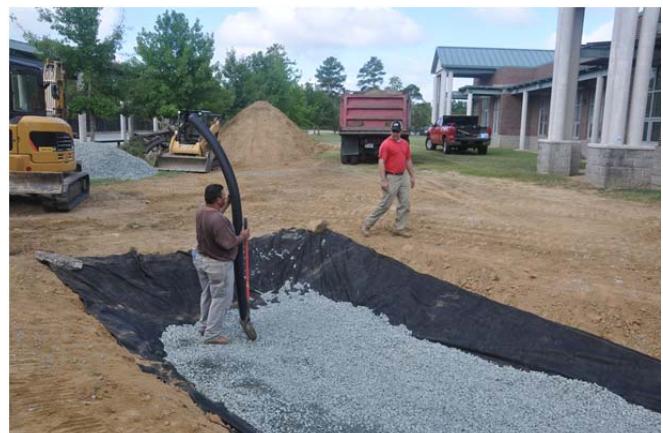
Photograph 5: Underdrain and gravel installation.

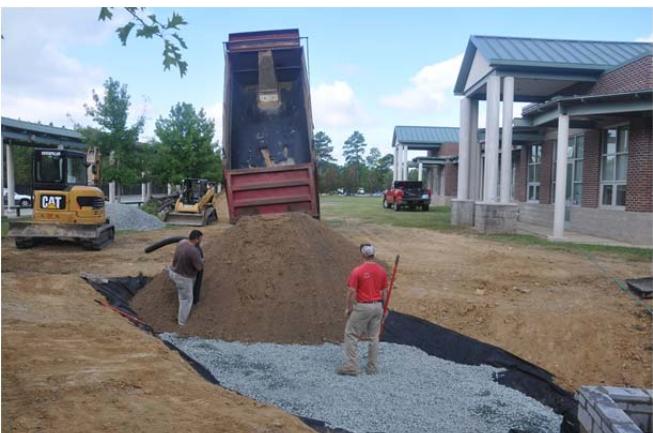
The next step was to backfill the area with the bioretention media to the specified design elevation (photographs 6, 7, & 8). The contractor carefully installed the media to avoid compaction and keep the surrounding soil out of the bioretention mix. The media consisted of approximately 85 – 88 percent sand, 8 – 12 percent fines, and 3 – 5 percent organic matter. The specified media should result in an infiltration rate of approximately 1 – 2 inches per hour.

Photograph 6: Media installation.

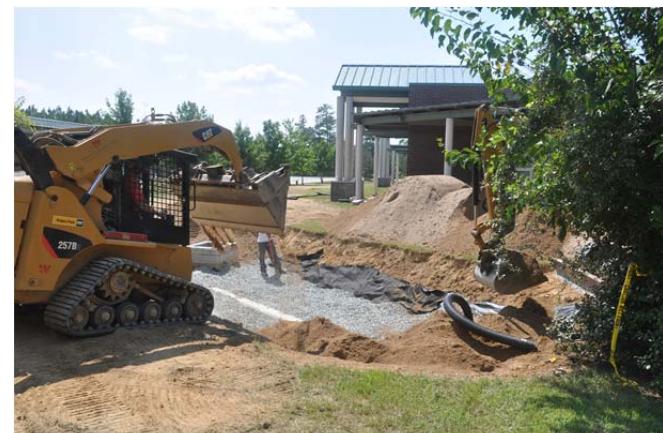
Photograph 7: Media installation.

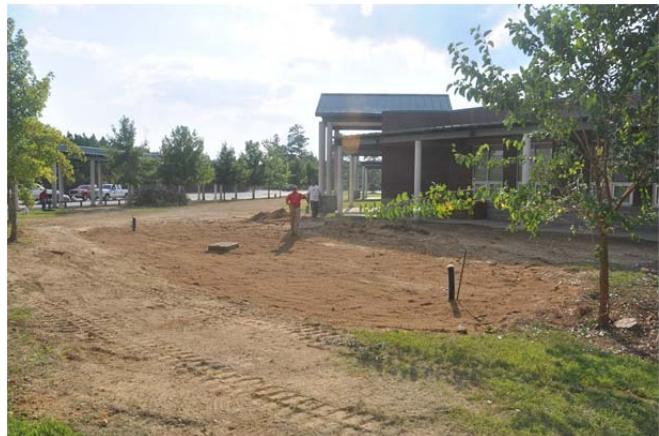
Photograph 8: Media installation complete

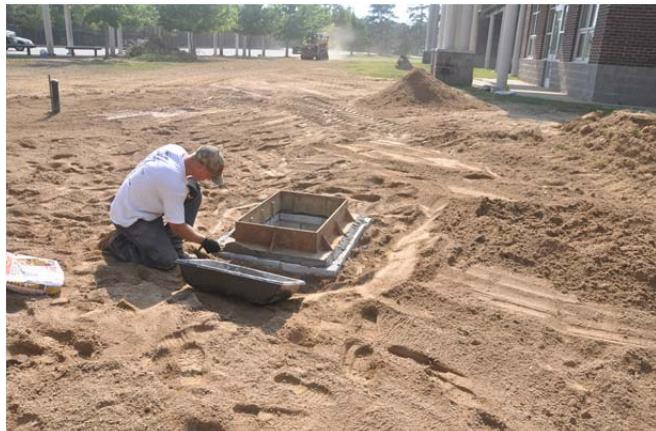
The existing drop inlet structure was raised to create an eight-inch ponding depth in the bioretention area (photograph 9). This depth allowed sufficient storage capacity to capture the runoff associated with a one-inch storm (photograph 10). Runoff from storms greater than one-inch can safely bypass the area through the top of the drop inlet without creating additional flooding or negatively impacting the bioretention area.

Photograph 9: Overflow structure

Assign an overflow device: An existing yard inlet will be utilized as the overflow device. The invert of the inlet will be raised by 0.9-feet to accommodate runoff storage. The new elevation is below the surrounding sidewalk so excess runoff should not back up onto the sidewalk.

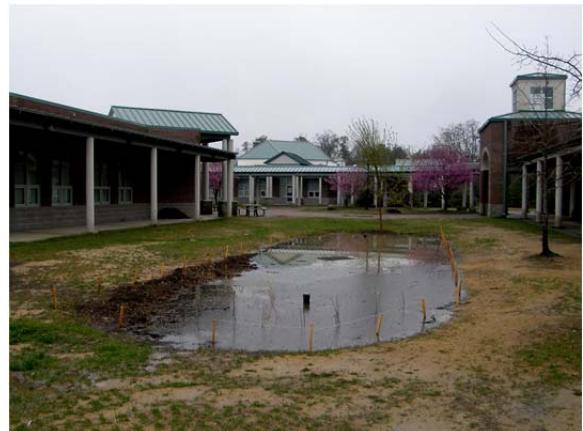
Photograph 10: After runoff event

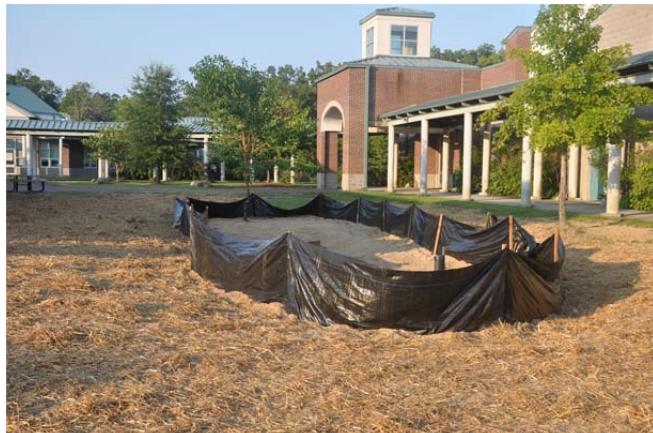
Silt fence was installed around the perimeter of the bioretention area to prevent sediment from the surrounding disturbed area from clogging up the imported bioretention media. Additional, the disturbed areas outside the bioretention area were stabilized with permanent grass seed and straw mulch (photograph 11).

Photograph 11: Post Construction

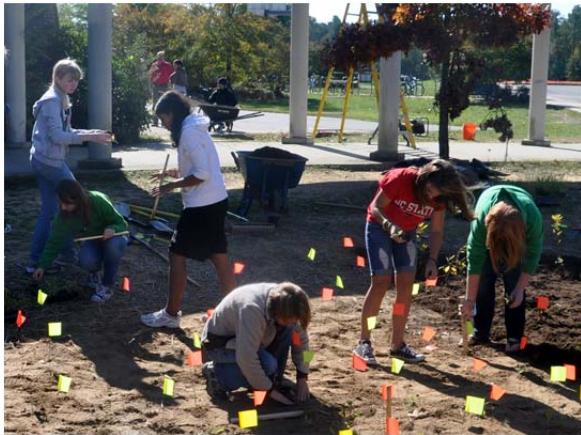
In October 2010, NCSU staff, Town staff, Friends of Bolin Creek volunteers, a documentary film crew, teachers and school staff, and five 8th grade science classes planted and mulched the garden (photographs 12 & 13). Native plants that can tolerate extremely dry and wet conditions were chosen for the garden. For the October 2010 planting, the following species were planted: *Asclepias tuberosa* “Butterfly weed”, *Echinacea purpurea* “Cone flower”, *Iris virginica* “Southern blue flag”, *Rudbeckia hirta* “Black-eyed Susan”, *Vernonia noveboracensis* “Iron Weed”, *Panicum virgatum* “Switchgrass”, *Muhlenbergia capillaris* “Sweet grass”, *Clethra alnifolia* “Sweet pepperbush”, and *Itea virginica* “Virginia willow”.

Photograph 12: Plant installation

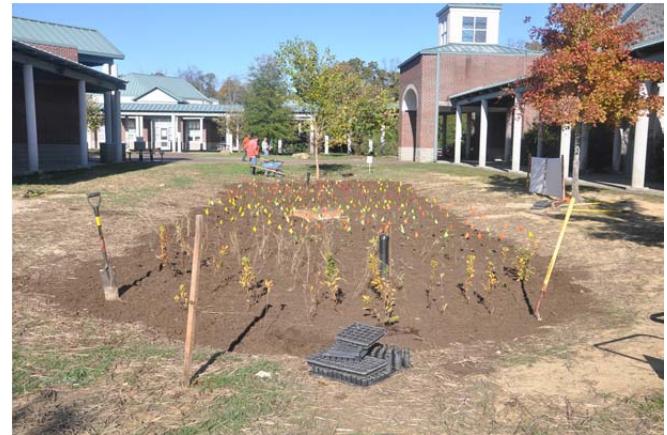
Photograph 13: Initial planting and mulch complete

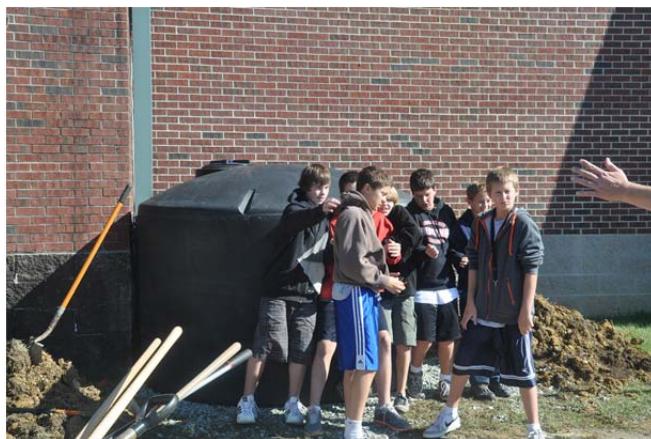
The students also helped NCSU staff install the 1,550-gallon cistern (photograph 14). The cistern was connected to an existing downspout off the gymnasium roof. Runoff collected in the cistern can be used to irrigate the bioretention area and the surrounding landscape. This will reduce municipal water use and the volume of runoff leaving the site. Experience with the cistern during the project period suggests that adding a pump to increase pressure would benefit irrigation by increasing the pressure. However, this would require extending electrical service, which is not currently available in proximity to the cistern. It is also worth noting that the site is well suited for the addition of two more cisterns if additional funds become available. Given interest in additional educational gardens, additional capacity could be both an environmentally and financially beneficial undertaking.

Photograph 14: Cistern installation

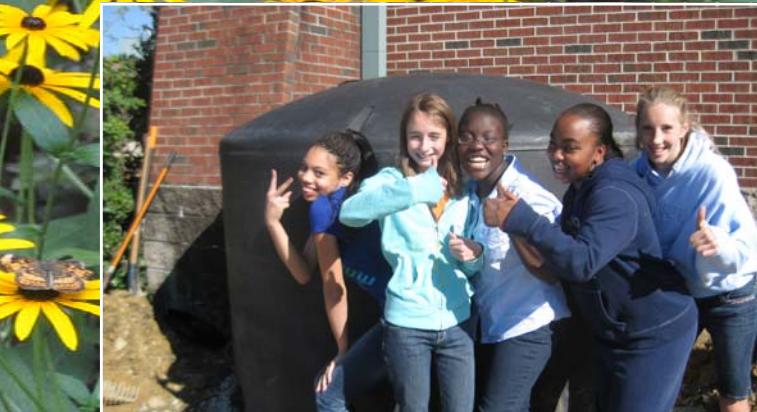
1,000-gallon cistern installed to collect roof runoff and irrigate the rain garden during dry periods while the plants become established.

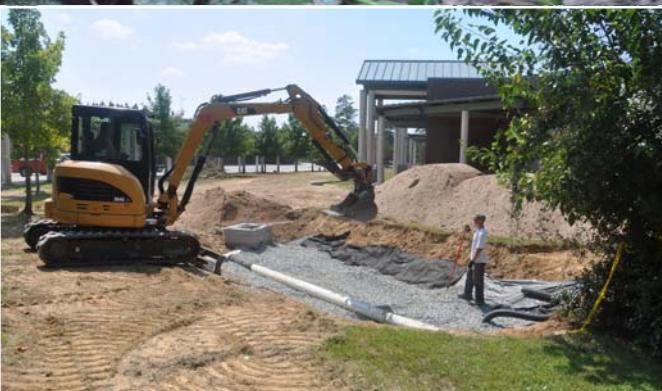
Construction: Rain garden was excavated, lined with geotextile fabric, a gravel underdrain, and 3-feet of engineered sandy soil.

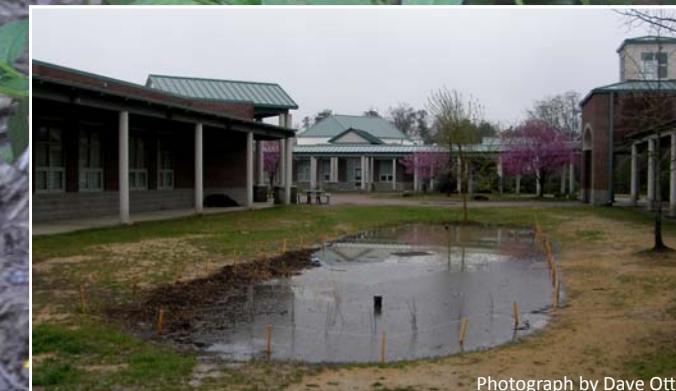
View of rain garden after a large rain event. Water ponded up to the outlet rim before infiltrating into the garden.
Photograph by Dave Otto

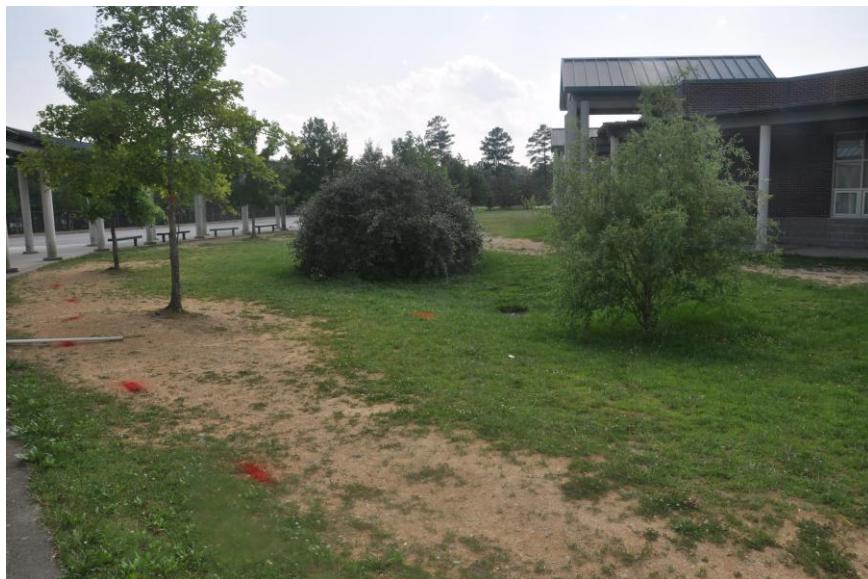
Terrain: A small grassed area on the northwest side of the gymnasium has been chosen for the proposed bioretention area. The proposed area is in a slight depressional area with an existing outlet structure. Runoff from adjacent roofs and a brick courtyard drain to the area. The existing outlet elevation will likely need to be raised to create a temporary ponding area.
